## APPENDIX B: HULL SURVEY

### Marine Survey MV LIGHTNING

VESSEL	: M/V LIGHTNING
OFFICIAL NO.	: 1048476
DOC. OWNER	: Massachusetts Bay Transportation Authority
LENGTH	: 75.8' (registered)
BREADTH	: 27.6'
HULL DEPTH	: 8.5'
GROSS TONS	: 70 (regulatory)
GROSS TONS	: 141 (ITC)
NET TONS	: 47 (regulatory)
NET TONS	: 54 (ITC)
PROPULSION	: Twin diesel water jet
BUILT	: 1996 / Gladding-Hearn Shipbuilding, Somerset, MA / Hull # P-308

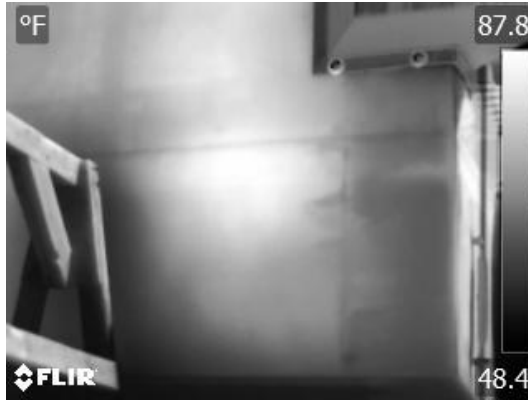
**IMAGE 1. Starboard Hull inboard aft**

The plain foam core is seen in the image. Core panel edges are seen in dark color. No findings are noted. A ladder is seen in the left of the image. The jet bucket guard is seen in the top right of the image.

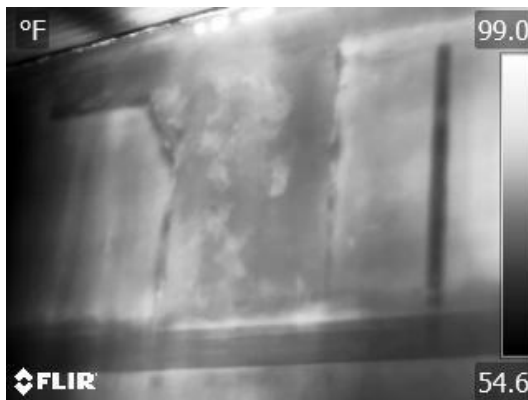
**IMAGE 2. Starboard Hull inboard aft**

A repair is seen in dark color with generous amounts of fairing.

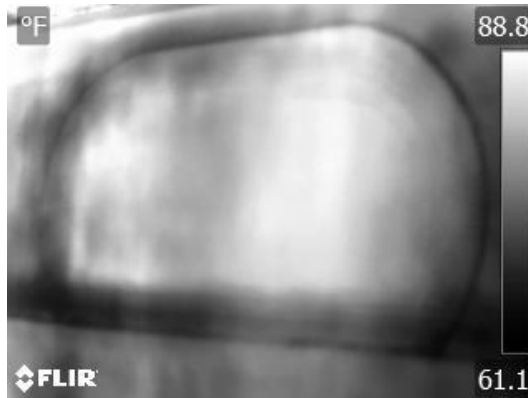
**IMAGE 3. Starboard Hull inboard**

Repaired area following the removal and installation of fuel tank. Plain foam core. The bottom of the image shows another repair near the waterline reported as ice damage. The repairs are intact. Scarfing of the laminate is seen.

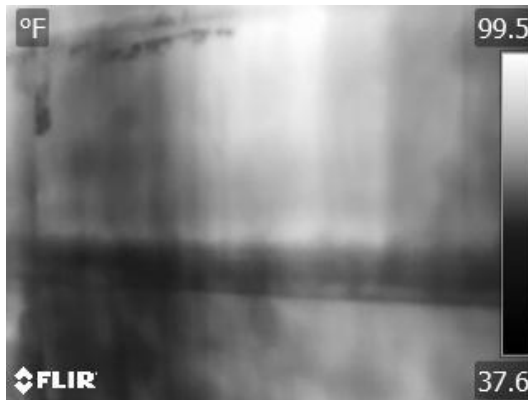
**IMAGE 4. Starboard Hull inboard**

Repair reported as ice damage seen at waterline in bottom of image. Repairs are seen at the top of the image. The repairs are intact.

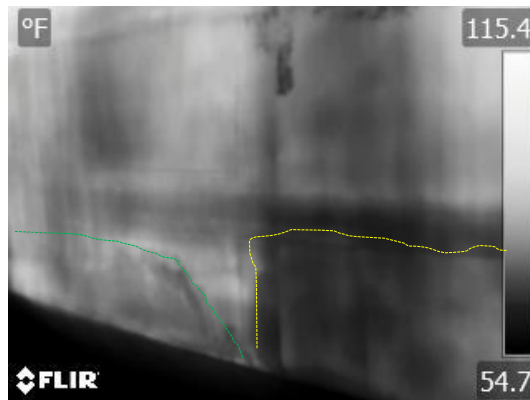
**IMAGE 5. Starboard Hull inboard**

The 2007 ice damage repair ends at the bottom right of image and is noted with a yellow line. A separate 2002 repair is seen in the left of the image and is noted with a green line.

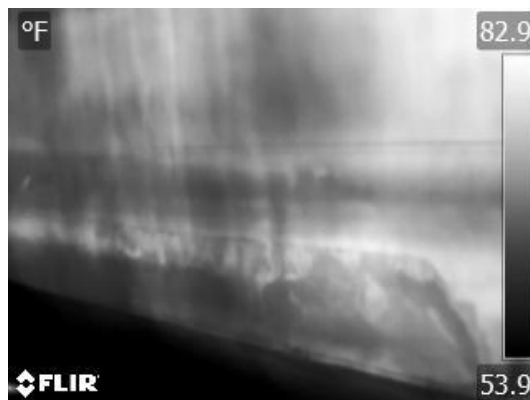
**IMAGE 6. Starboard Hull inboard forward**

A separate 2002 repair from the one aft is seen in the image. Small light colored anomalies are seen with characteristics of poor adhesion of the outer laminate to the core.

Areas where the potential of the exterior laminate not being adhered to the core should be investigated further and repaired.

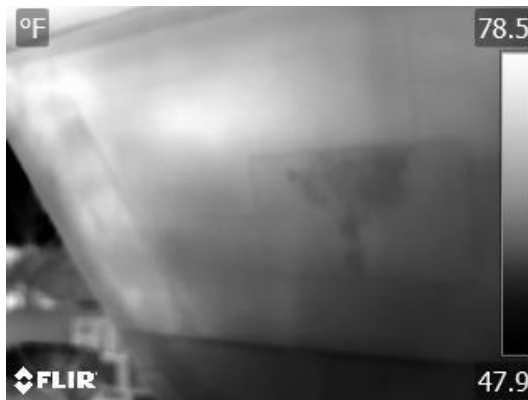
**IMAGE 7. Starboard Hull inboard forward**

A past repair is seen in dark color in the right of the image. Core panel edges are seen in dark color.

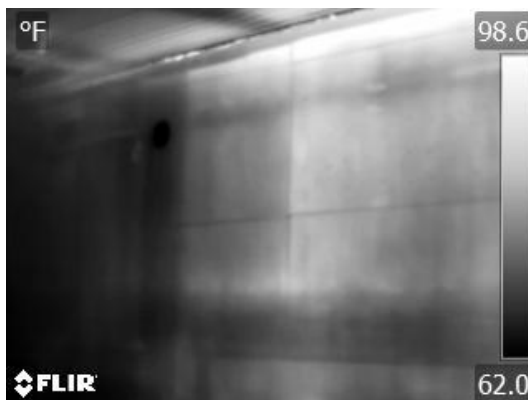
**IMAGE 8. Port Hull inboard aft**

The 2007 ice damage repair at the waterline can be seen in the bottom of the image. Scarfing of the laminates is seen. Core panel edges in the plain foam are seen in dark color. A through hull is seen in the top left of the image. No core termination is seen around the through hull.

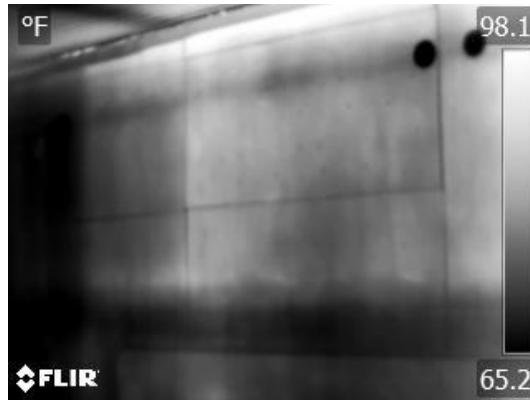
**IMAGE 9. Port Hull inboard aft**

Through hulls in plain foam. There is no core termination surrounding the through hulls. No findings are noted.

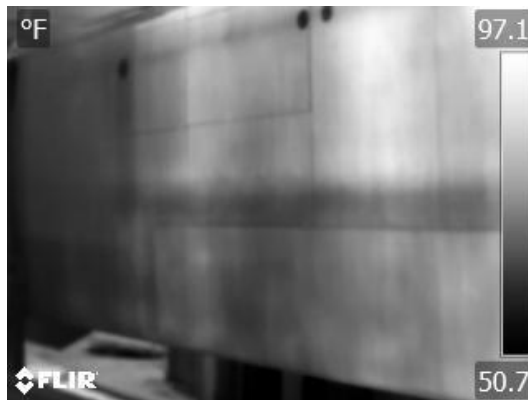
**IMAGE 10. Port Hull inboard aft**

The trailing end of the 2007 ice damage repair near the waterline is seen in the bottom of the image. No findings are noted. Core panel edges are seen in dark color

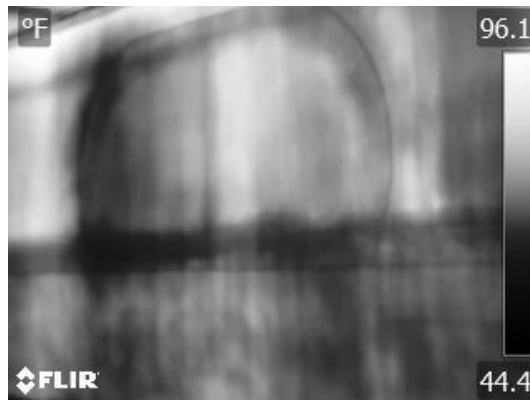
**IMAGE 11. Port Hull inboard**

Repaired area following the removal and installation of fuel tank. Plain foam core. The bottom of the image shows the 2007 ice repair near the waterline. Scarfing of the laminates is seen at the repairs. No findings are noted.

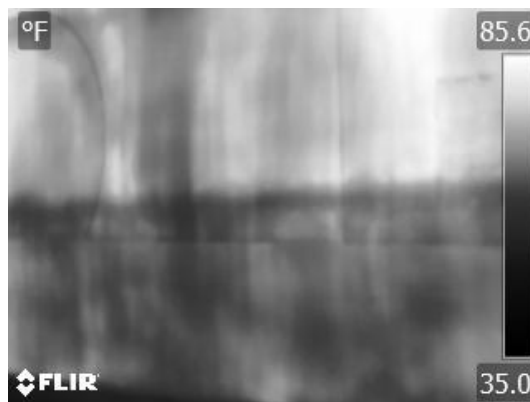
**IMAGE 12. Port Hull inboard**

Repair for the fuel tank leading edge is in the left of the image. The 2007 ice damage repair at the waterline is at the bottom of the image. The plain foam core panel edges are seen in dark color. Scarfing of the laminates is seen at the repair. Core panel edges are seen in dark color. Fill at the chine area is seen in dark color. No

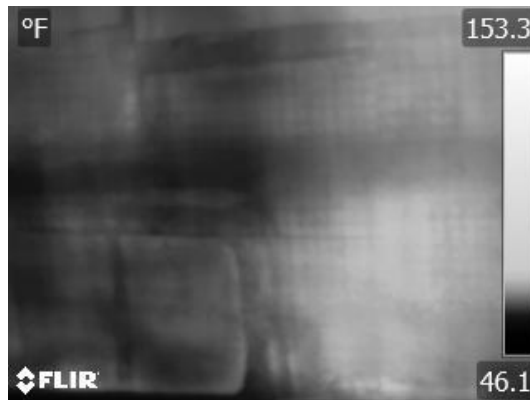
**IMAGE 13. Port Hull inboard**

The waterline repair made with plain foam ends in the bottom of the image. Cross cut foam is seen in location differing from the construction of the starboard hull.

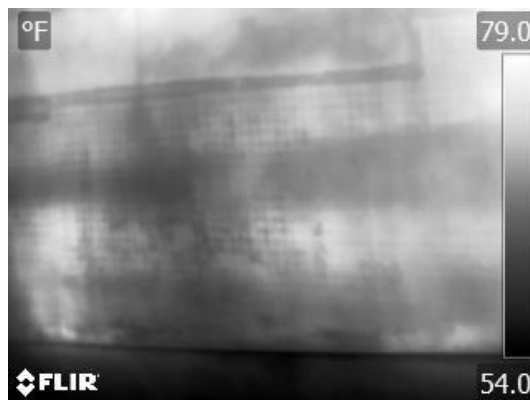
**IMAGE 14. Port Hull inboard forward**

Dark colored anomalies characteristic of moisture ingress are seen in the location of the cross cut foam core.

The discovery of potential moisture ingress to the core in areas of the vessel should be investigated further. Following further investigation, a repair schedule can be completed.

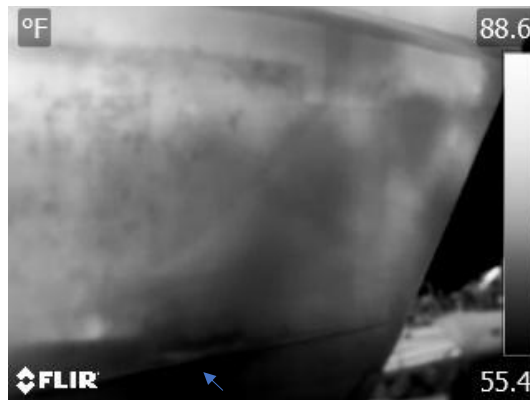
**IMAGE 15. Port Hull inboard forward**

Damage at the chine in dark color is noted with a blue arrow.

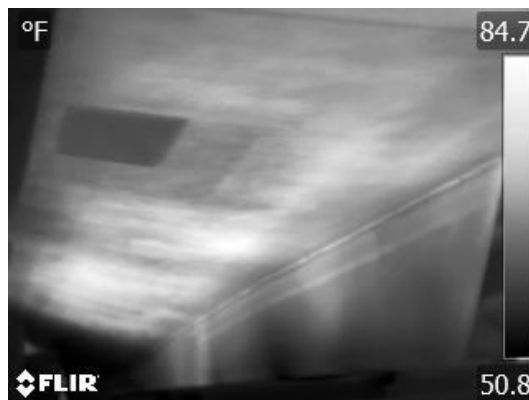
**IMAGE 16. Starboard hull aft inboard bottom**

A grounding plate is seen in the image on the left. The grounding plate is installed in a monolithic area of dark colored laminate. The trailing edge of the keel is seen in the left of the image. No findings are noted.

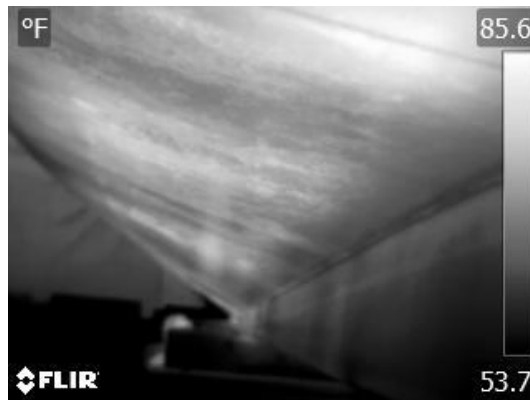
**IMAGE 17. Starboard hull mid inboard bottom**

The keel is seen in the right of the image. The image is taken looking forward. No findings are noted.

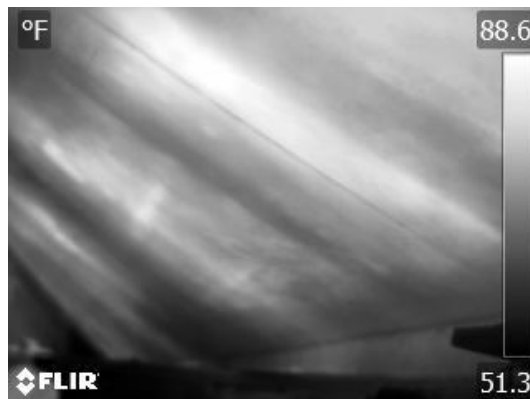
**IMAGE 18. Starboard hull forward inboard bottom**

The leading edge of the keel is seen in the bottom of the image. Core panel edges are seen in dark color. No findings are noted.

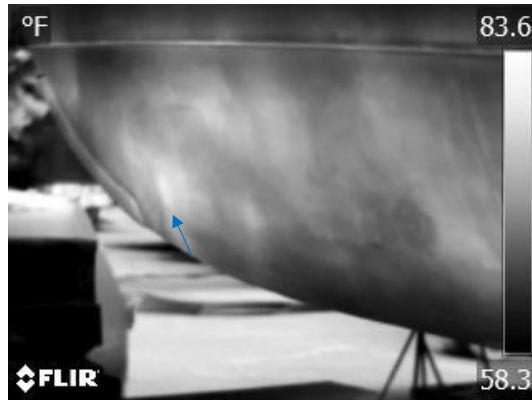
**IMAGE 19. Starboard hull forward inboard bottom**

The blue arrow notes a light colored anomaly characteristic of a void between the core and the outer laminates

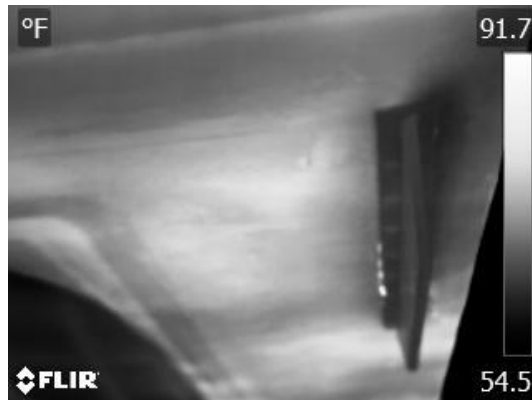
**IMAGE 20. Starboard hull aft outboard bottom**

A bolted on skeg is seen in the right of the image. The jet intake is seen in dark color in the left of the image. No findings are noted.

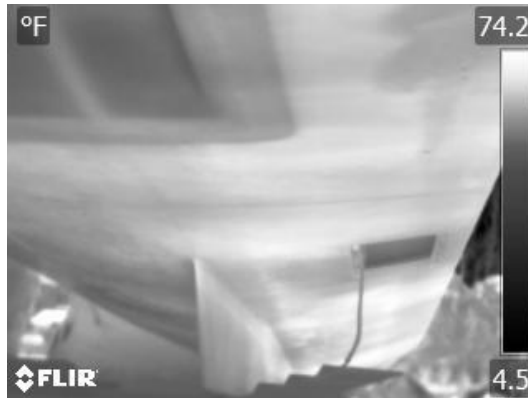
**IMAGE 21. Starboard hull aft outboard bottom**

The jet intake is seen in the left of the image with monolithic laminate in dark color around it. A sea water intake is seen in the right of the image. The trailing edge of the keel is seen at the bottom of the image. No findings are noted.

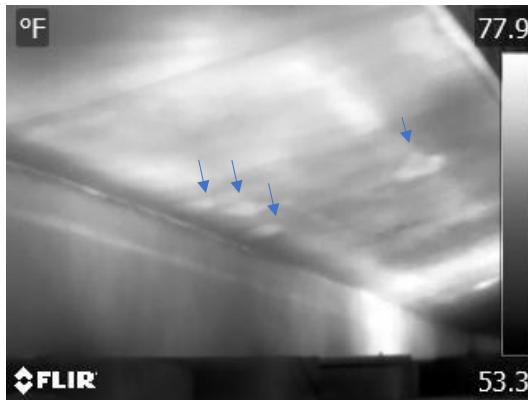
**IMAGE 22. Starboard hull aft outboard bottom**

Four anomalies in light color with characteristics of separation of the outer laminate from the core are marked with blue arrows.

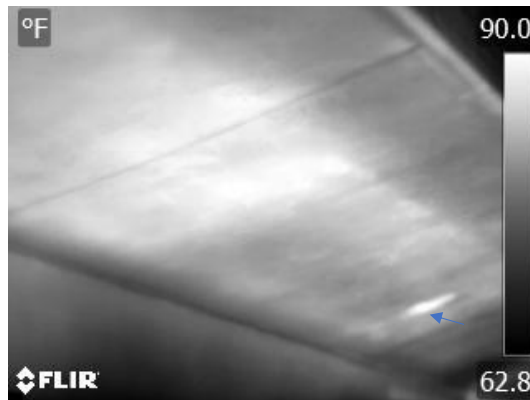
**IMAGE 23. Starboard hull aft outboard bottom**

One anomaly in light color with characteristics of separation of the outer laminate from the core are marked with a blue arrow.

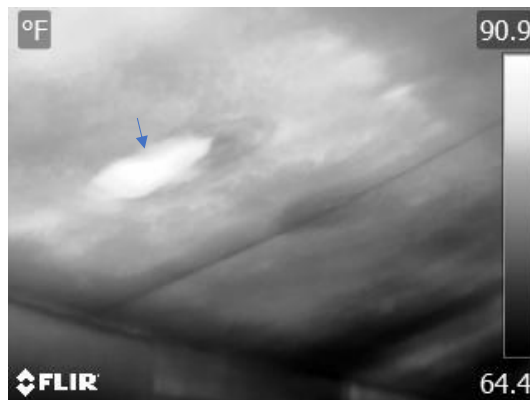
**IMAGE 24. Starboard hull outboard bottom**

An anomaly in light color with characteristics of separation of the outer laminate from the core are marked with a blue arrow.

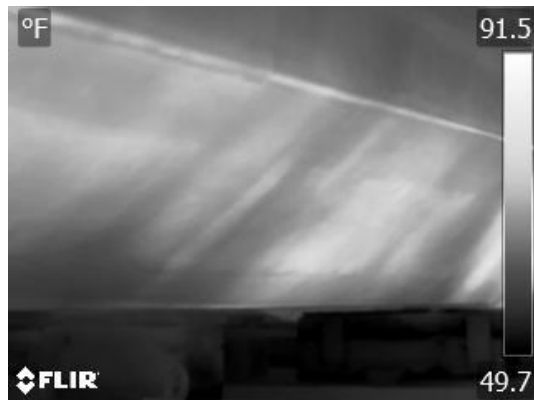
**IMAGE 25. Starboard hull outboard bottom forward**

The image is taken just forward of the leading edge of the keel. No findings are noted.

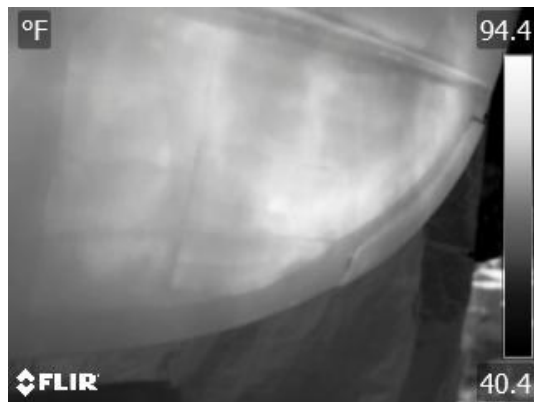
**IMAGE 26. Starboard hull outboard bottom forward**

Monolithic laminate is seen at the bow at centerline in dark color. No findings are noted.

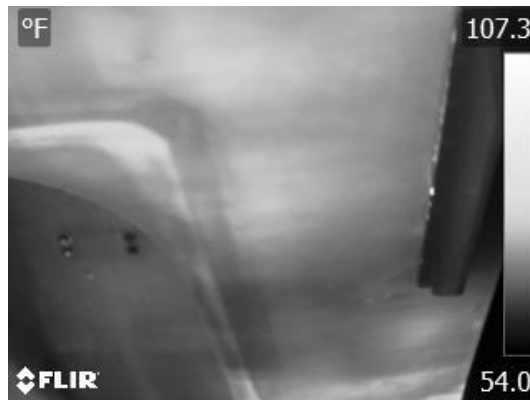
**IMAGE 27. Port Hull aft inboard bottom FT**

A bolted on skeg is seen in the right of the image. The jet intake is seen in dark colored solid laminate in the left of the image.

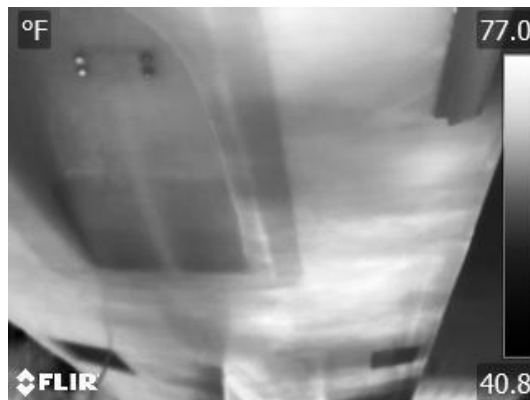
**IMAGE 28. Port Hull aft inboard bottom**

The jet intake is seen in the left of the image. The seawater intake is seen in the lower left of the image. A grounding plate is seen in the bottom right. The trailing edge of the keel is seen in the bottom of the image. No findings are noted.

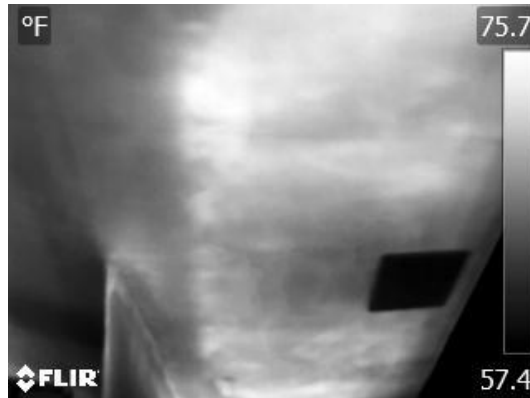
**IMAGE 29. Port Hull aft inboard bottom**

The trailing edge of the keel is seen in the left of the image. A bonding plate is seen in the right of the image. Additional laminate at centerline is seen in dark color. No findings are noted.

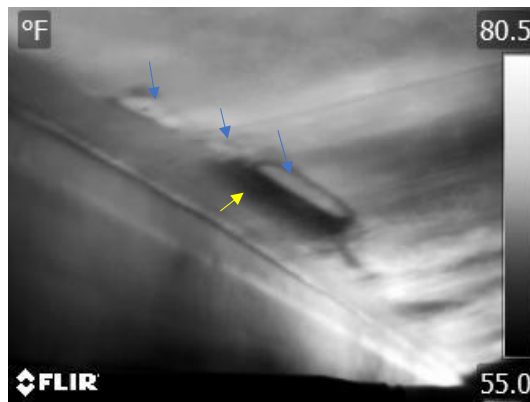
**IMAGE 30. Port Hull inboard bottom**

Three anomalies in light color with characteristics of separation of the outer laminate from the core are marked with blue arrows. The yellow arrow notes a dark colored anomaly characteristic of moisture ingress to the laminate.

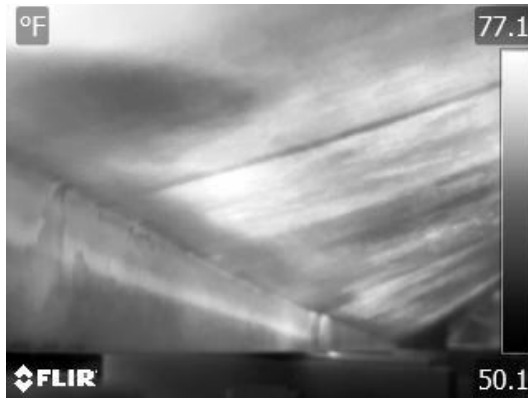
**IMAGE 31. Port Hull inboard bottom**

Core panel edges are seen in dark color. The keel is seen at the bottom of the image. No findings are noted.

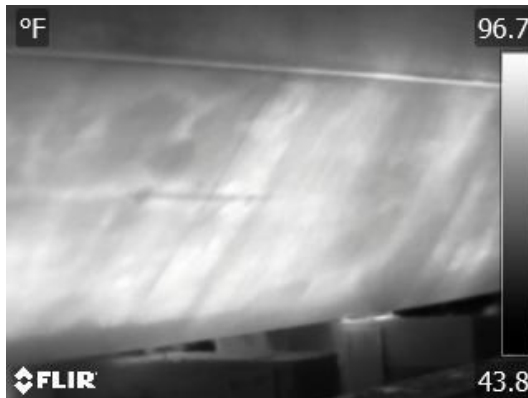
**IMAGE 32. Port Hull inboard bottom**

Core panel edges are seen in dark color. The chine is seen at the top of the image. No findings are noted.

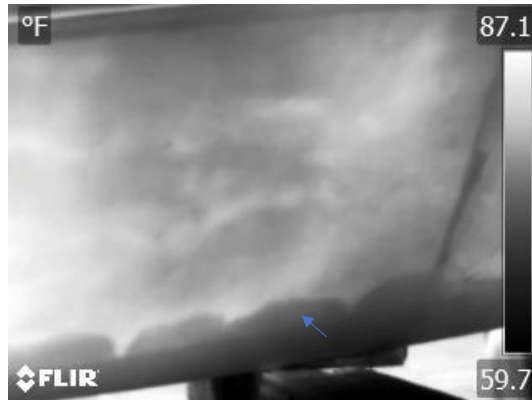
**IMAGE 33. Port Hull inboard bottom**

Anomalies near centerline with characteristics of moisture ingress are noted with a blue arrow in dark color

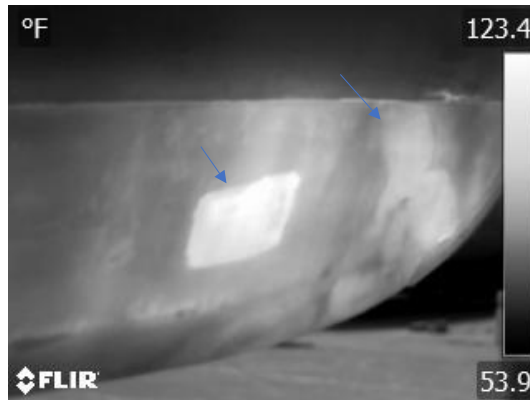
**IMAGE 34. Port Hull inboard bottom forward**

Blue arrows not anomalies in light color with characteristics of separation of the outer laminate from the core.

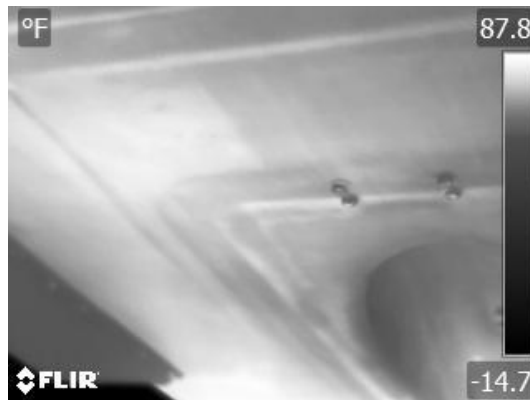
**IMAGE 35. Port hull aft outboard bottom**

The jet intake is seen in the right of the image in monolithic laminate. The outboard skeg is seen in the left of the image in dark color. No findings are noted

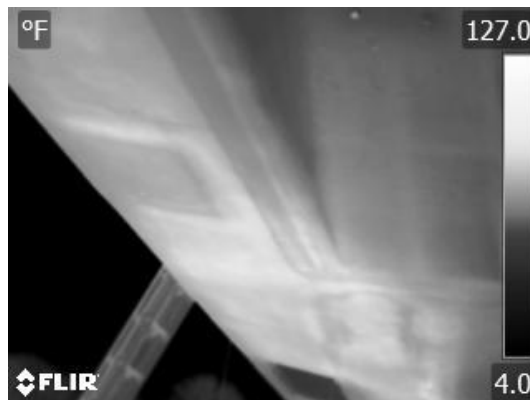
**IMAGE 36. Port hull aft outboard bottom**

A dark colored area of solid laminate is seen outboard of the jet intake. The jet intake is seen in the right of the image. No findings are noted.

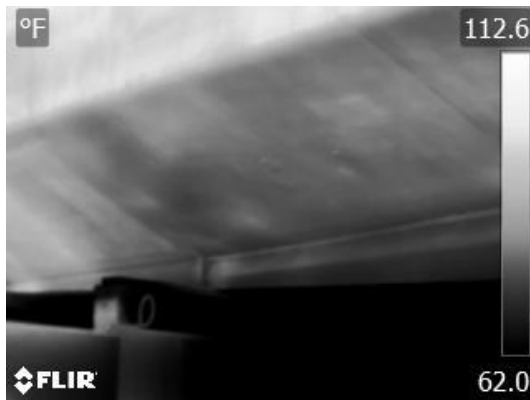
**IMAGE 37. Port hull outboard bottom**

The leading edge of the keel is seen in the image. Core panel edges are seen in dark color. No findings are noted.

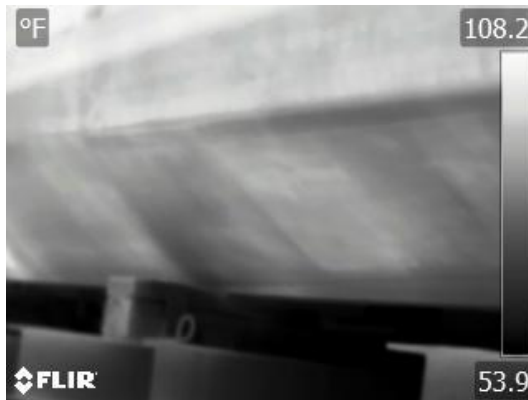
**IMAGE 38. Port hull outboard bottom**

The leading edge of the keel is seen in the image. No findings are noted.

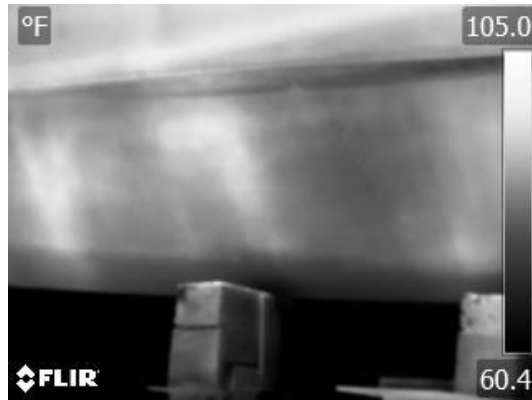
**IMAGE 39. Port hull outboard bottom**

The chine is seen in the top of the image. No findings are noted.

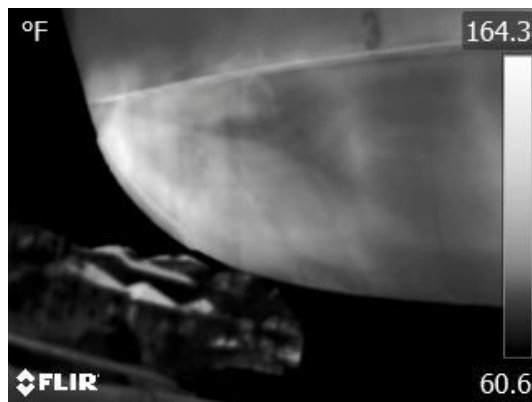
**IMAGE 40. Port hull outboard bottom**

The bow is seen in the image. No findings are noted.

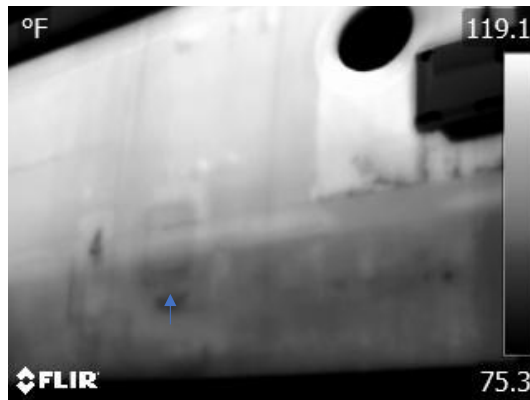
**IMAGE 41. Port hull aft outboard topsides**

A past repair is seen in the image in dark color and is noted with a blue arrow.. The metal guard for the jet bucket is seen in dark color in the right of the image.

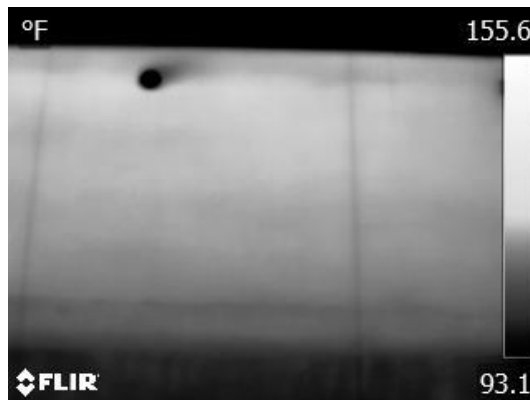
**IMAGE 42. Port hull aft outboard topsides**

A through hull is seen in the top of the image. Core panel edges are seen in dark color. No findings are noted.

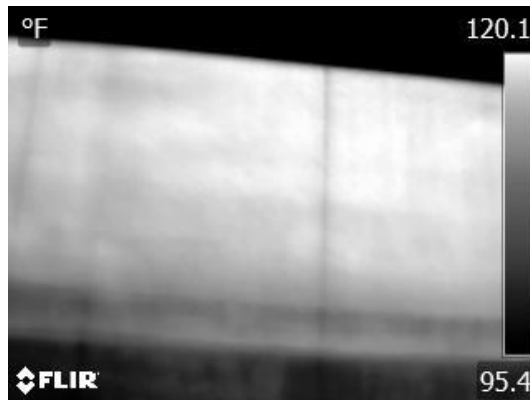
**IMAGE 43. Port hull outboard topsides**

The core panel edges are seen in dark color. No findings are noted.

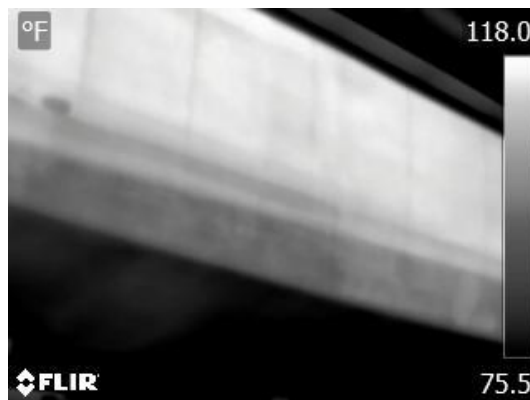
**IMAGE 44. Port hull outboard topsides**

The core panel edges are seen in dark color. No findings are noted.

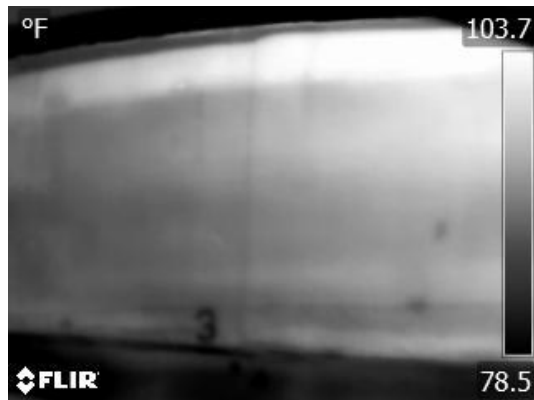
**IMAGE 45. Port hull outboard topsides**

The core panel edges are seen in in dark color. No findings are noted

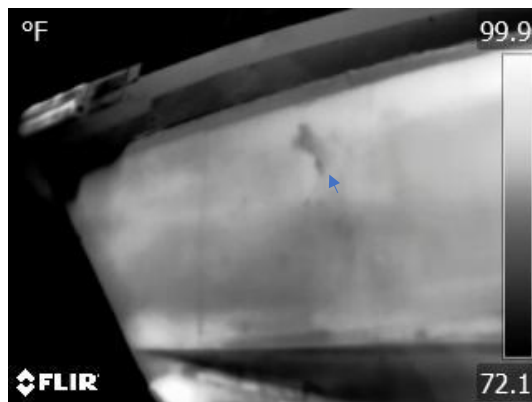
**IMAGE 46. Port hull outboard topsides**

The bow is seen in the left of the image and is noted with a blue arrow. A past repair is seen in dark color in the topsides. The repair is intact. No findings are noted.

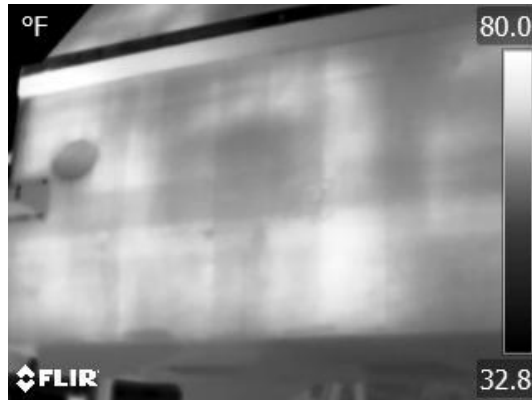
**IMAGE 47. Starboard hull aft outboard topsides**

The metal jet bucket guard is seen in the left of the image. No findings are noted.

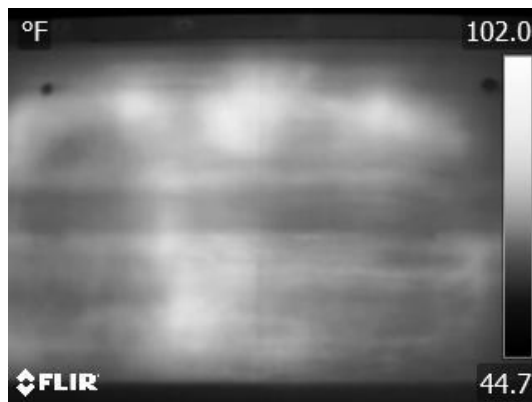
**IMAGE 48. Starboard hull aft outboard topsides**

A through hull is seen in the top left of the image. No findings are noted.

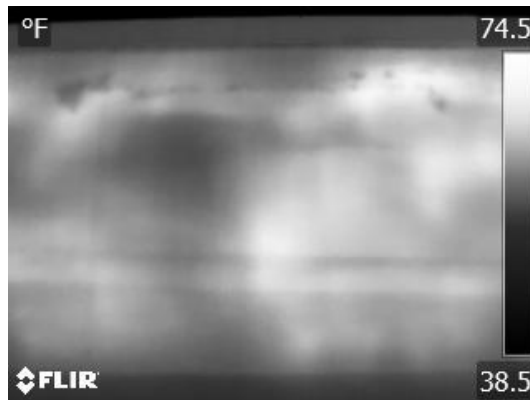
**IMAGE 49. Starboard hull aft outboard topsides**

Previous repairs are seen at the top of the image in the image in dark color. The repairs are intact. No findings are noted.

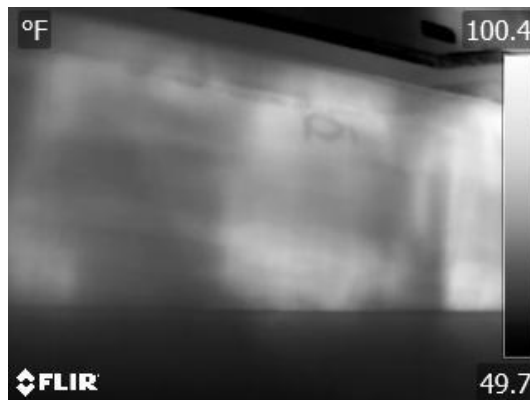
**IMAGE 50. Starboard hull aft outboard topsides**

Previous repairs are seen at the top of the image in the image in dark color. The repairs are intact. No findings are noted.

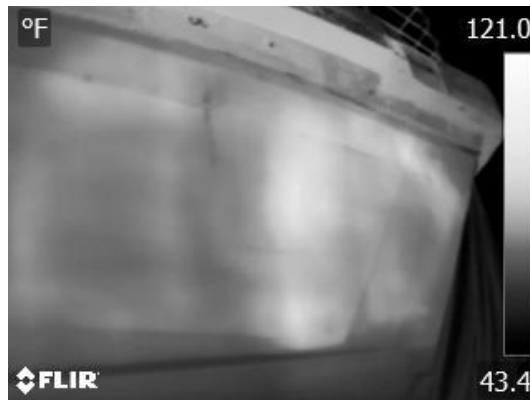
**IMAGE 51. Starboard hull aft outboard topsides**

The bow is seen in the right of the image. No findings are noted.
